Manhole Inspection Summary

Manhole # S45EE_007MH

Insp Date: **3/11/08 9:06 AM**

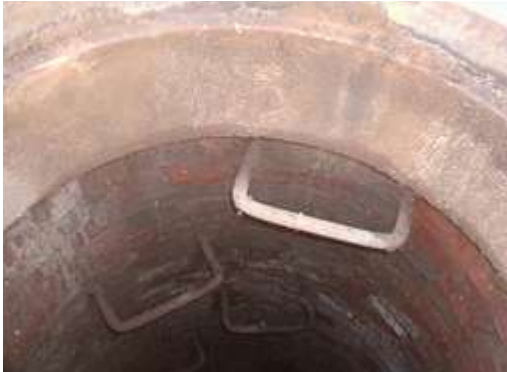
Defect 2

☒ **Leaks**

frame leaks

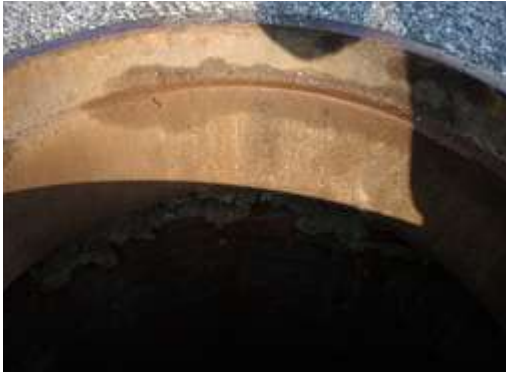
Defect 1

Infiltration: ☐ None ☐ Joint ☐ Cracks ☒ **Mortar** ☐ Roots ☒ **Wall**

adjustment joint

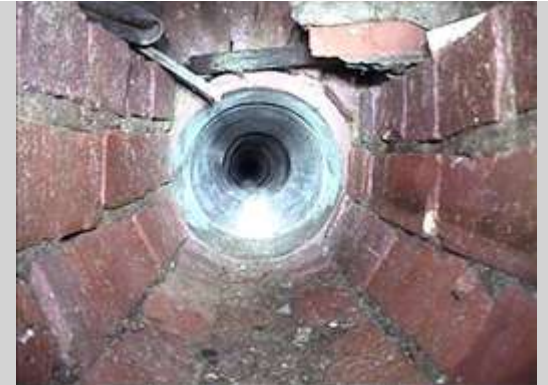
12 O'Clock Outflow

8 in. Circular Gravity Sewer
Pipe Out @ 12 O'Clock

Infiltration: **None** Pipe Seal Cond: **Sound**

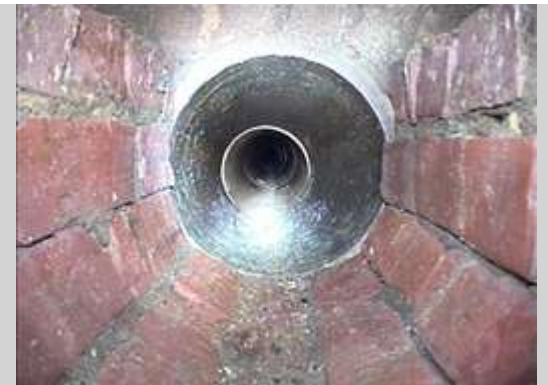
6 O'Clock Inflow

8 in. Circular Gravity Sewer
Pipe In @ 6 O'Clock

Infiltration: **None** Pipe Seal Cond: **Sound**
